Examined object: Effect of Lambda System Cleaning Products

About the effect of Lambda System Cleaning Products

No. 04-1628-00-01

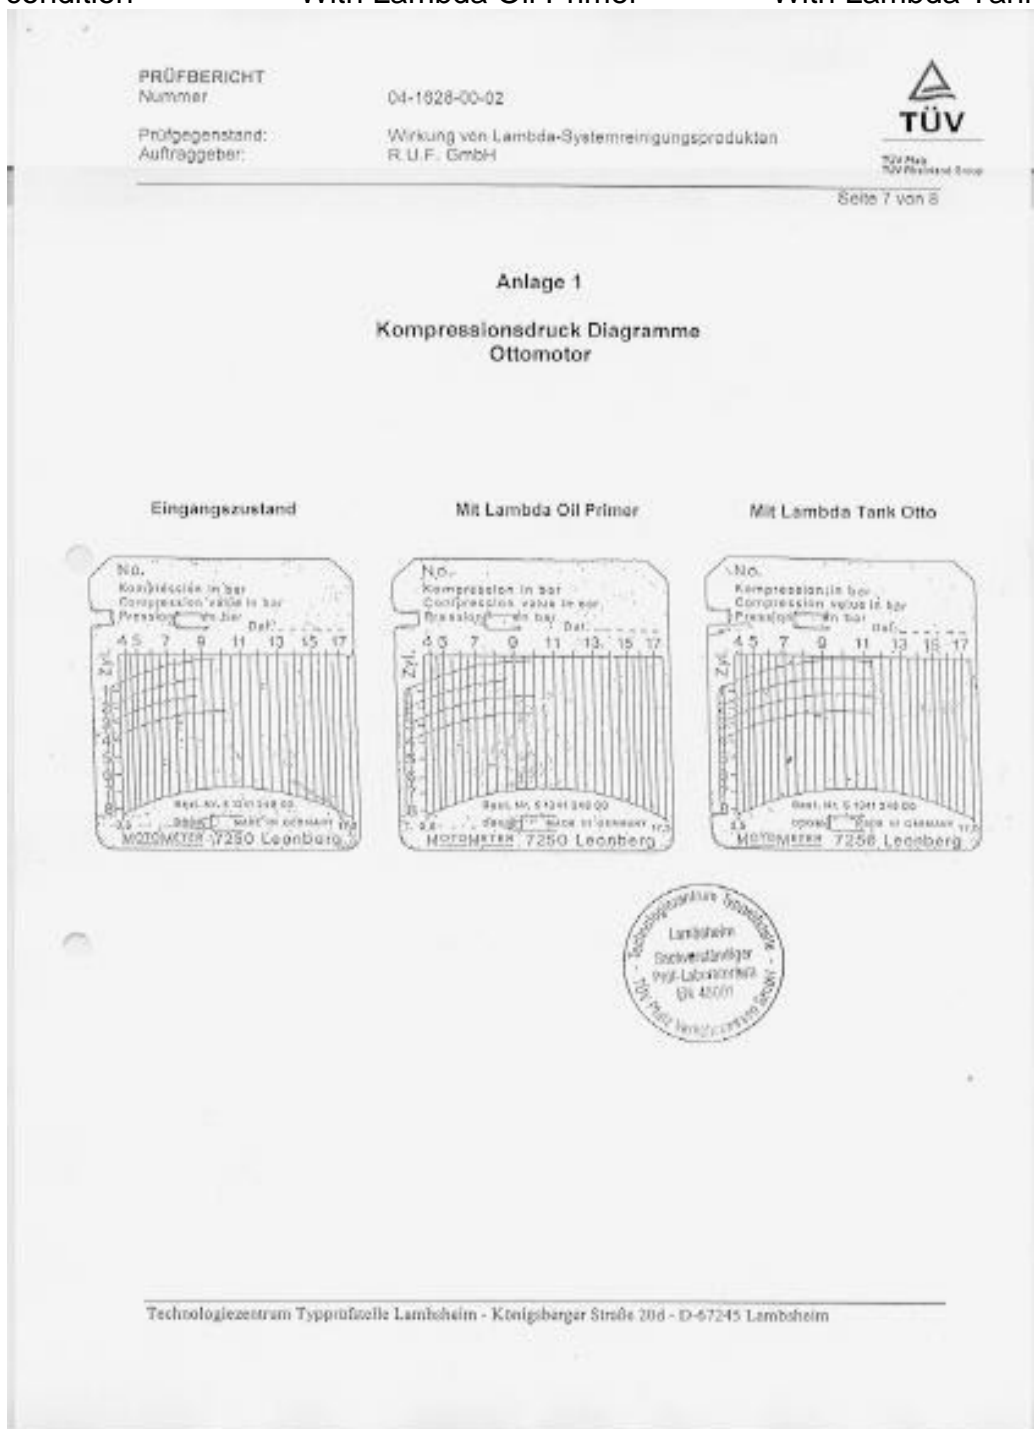
Enclosure 1

Compression pressure diagrams
Otto engine

Initial condition

With Lambda Oil Primer

With Lambda Tank Otto

Compression pressure (bar)				Notes
	Cyl. 1	Cyl. 2	Cyl. 3	Cyl. 4	
Initial condition	9.75	9.00	8.75	10.25	Uneven compression pressure, deviations partly bigger than 1 bar
With Lambda Oil Primer	9.75	8.75	10.00	10.00	Substantial increase of compression pressure at cylinder 3.
Comparison before - after	-	-0.25*	+1.25	-0.25*	Increase of the compression pressure at cylinder 3 caused by effect on the piston rings/piston ring slots.

Compression pressure (bar)				Notes
	Cyl. 1	Cyl. 2	Cyl. 3	Cyl. 4	
Initial condition	9.75	8.75	10.00	10.00	Uneven compression pressure, deviations partly bigger than 1 bar
With Lambda Tank Otto	11.00	11.00	11.5	11.00	Very good, even compression pressure.
Comparison before - after	+1.25	+2.25	+1.5	+1.00	Substantial increase of the compression pressure at all cylinders, caused by effect on the valves and / or piston rings.

Engine oil temperature at all compression pressure measurements: 92 – 96 °C.

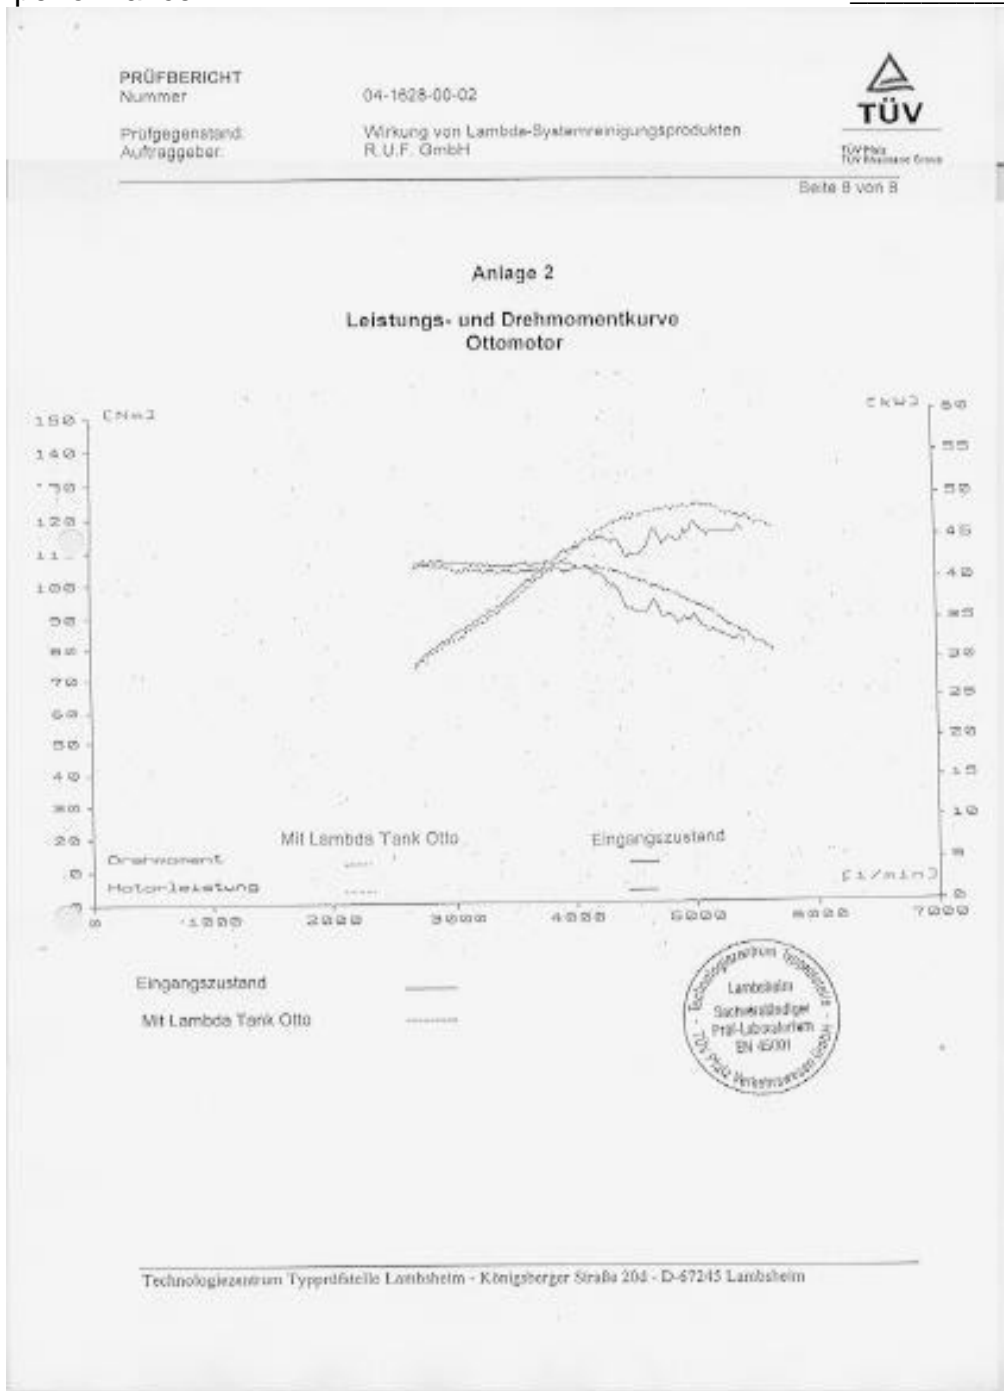
Enclosure 2

Performance and torque curve
Otto engine

Torque
Engine performance

with Lambda Tank Otto

Initial Condition

Initial condition: Between 4,300 – 5,500 min⁻¹ revs per minute, the full load curve of the engine shows a slump with irregular process, which might indicate existing disturbances in the air/fuel mixture, the gas change or the ignition.

In the context of the measuring tolerance no measurable changes in the full load curve of the engine could be recognized.

The slump determined in the initial condition in the full load characteristic in the speed range $4,300 - 5,500 \text{ min}^{-1}$ was eliminated. The maximum power loss amounted 4.4 kW with $4,460 \text{ min}^{-1}$. After the employment of the Lambda Tank Otto, the full load curve is smooth and inconspicuous.
